## Detection of Potential Induced Degradation in c-Si PV Panels Using Electrical Impedance Spectroscopy

*Citation (APA):*  
Oprea, M., Spataru, S., Sera, D., Basu, R., Andersen, A. R., & Poulsen, P. B. (2016). *Detection of Potential Induced Degradation in c-Si PV Panels Using Electrical Impedance Spectroscopy*. Poster session presented at 42nd IEEE Photovoltaic Specialists Conference, New Orleans, Louisiana, United States.

# Detection of Potential Induced Degradation in c-Si PV Panels Using Electrical Impedance Spectroscopy

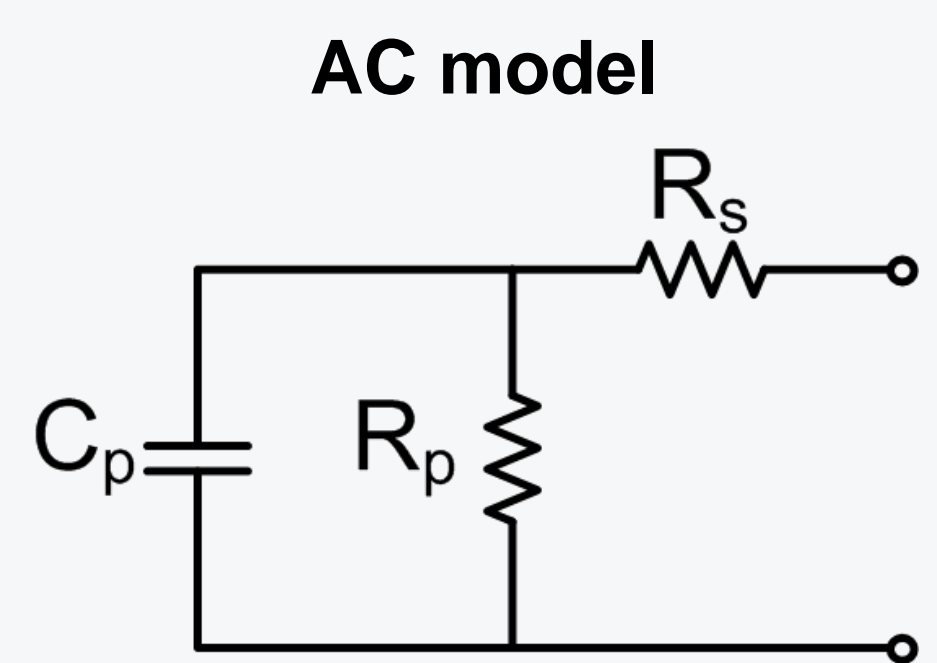
- The equivalent circuit model of PV panel used for the parameter fitting. In this case the emphasis is on the parallel components  $C_p$  and  $R_p$ .

- To determine the parameters of the equivalent circuit equation (1) is decomposed in real (2) and imaginary (3) parts. The two corresponding models are fitted to the IS measurements.

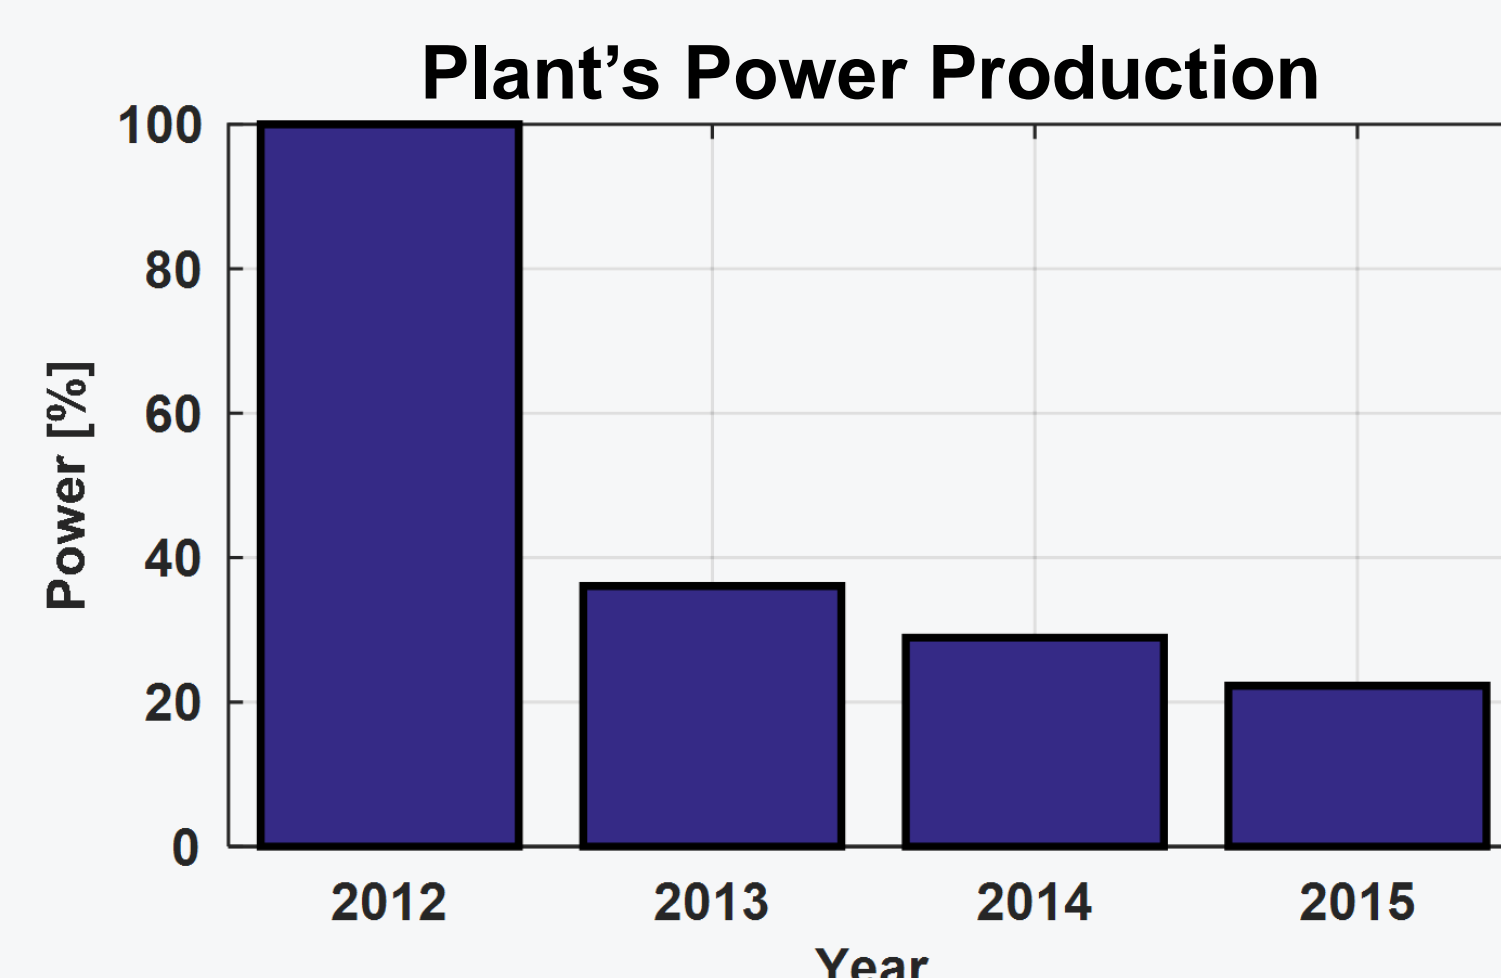
- A residential PV plant was inspected for faults, since the plant experienced a dramatic loss in power generation. The figure to the right present the evolution of the plant.

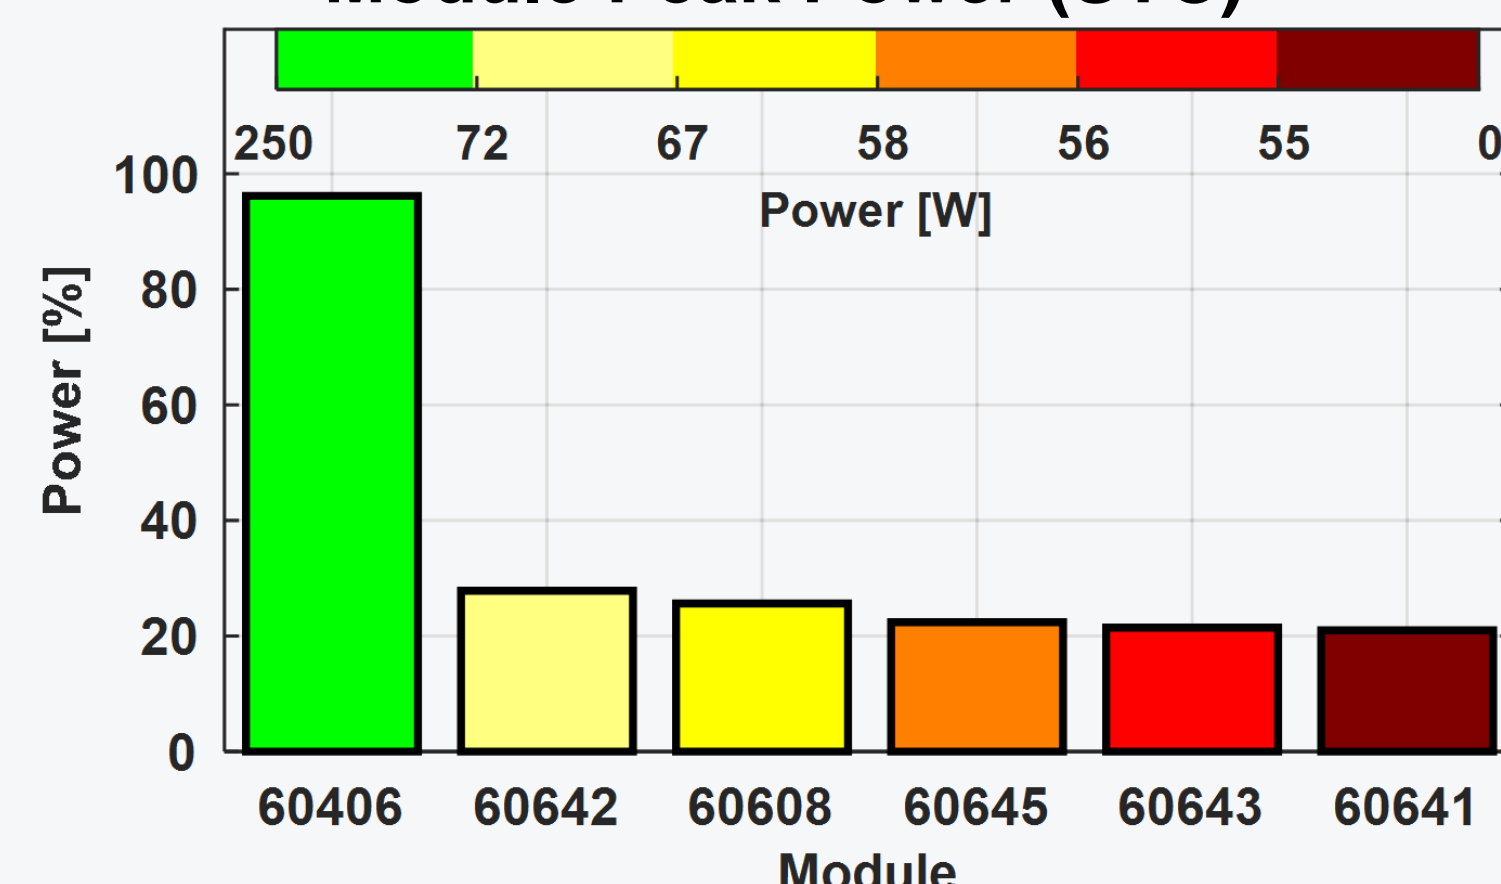
### Module Peak Power (STC)

- The best and five worst performing modules were identified in the field using the Z100 PV tester and were selected for laboratory tests.

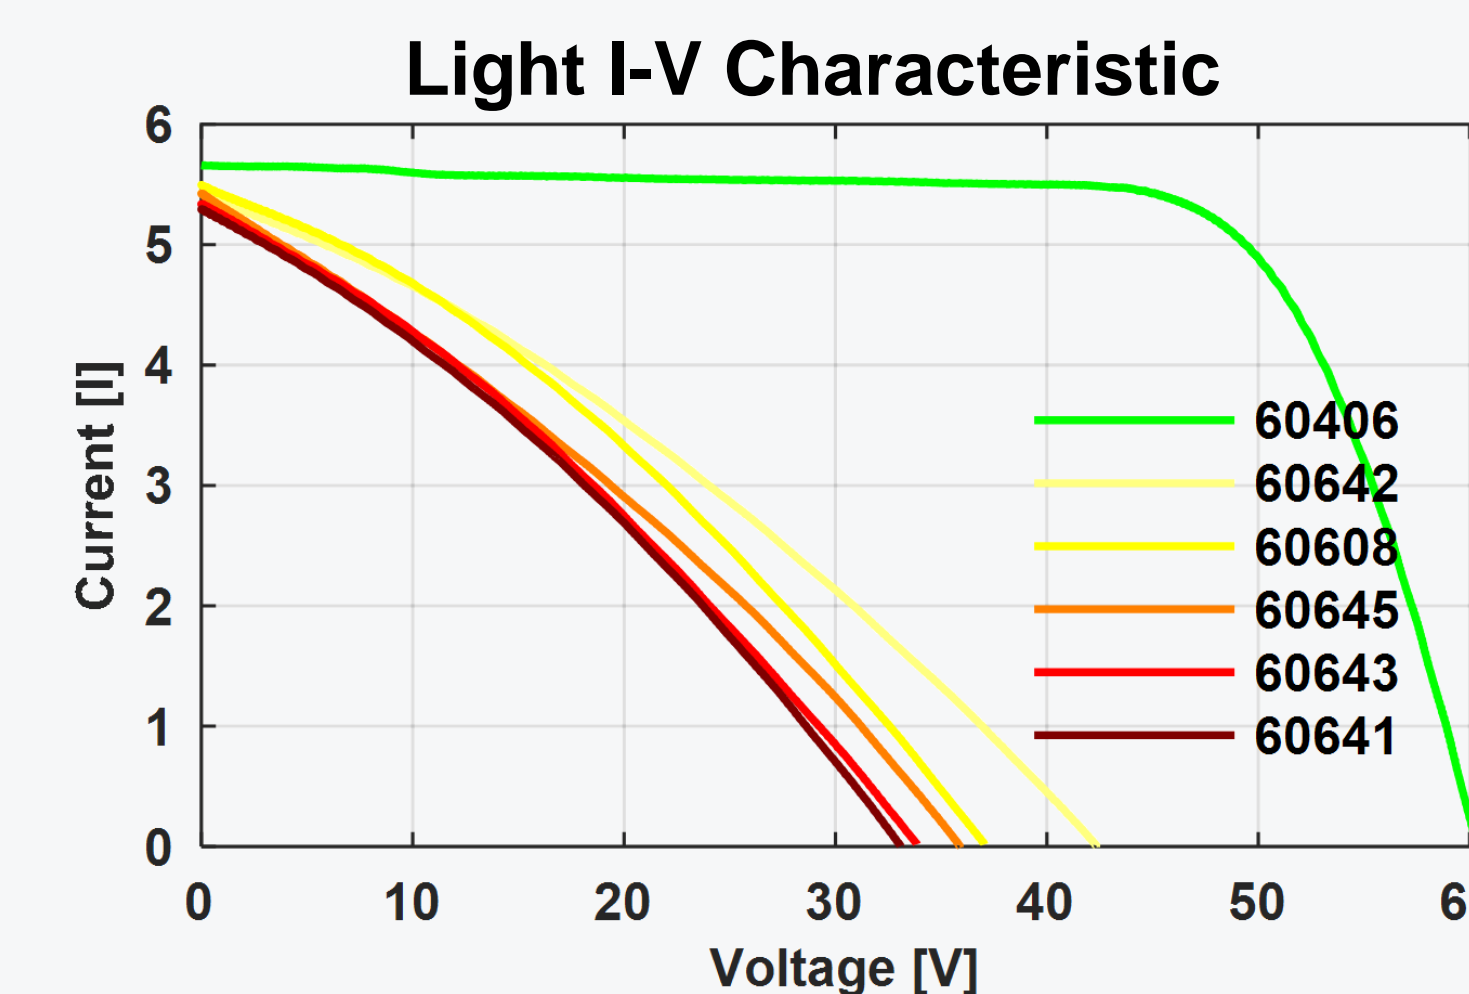
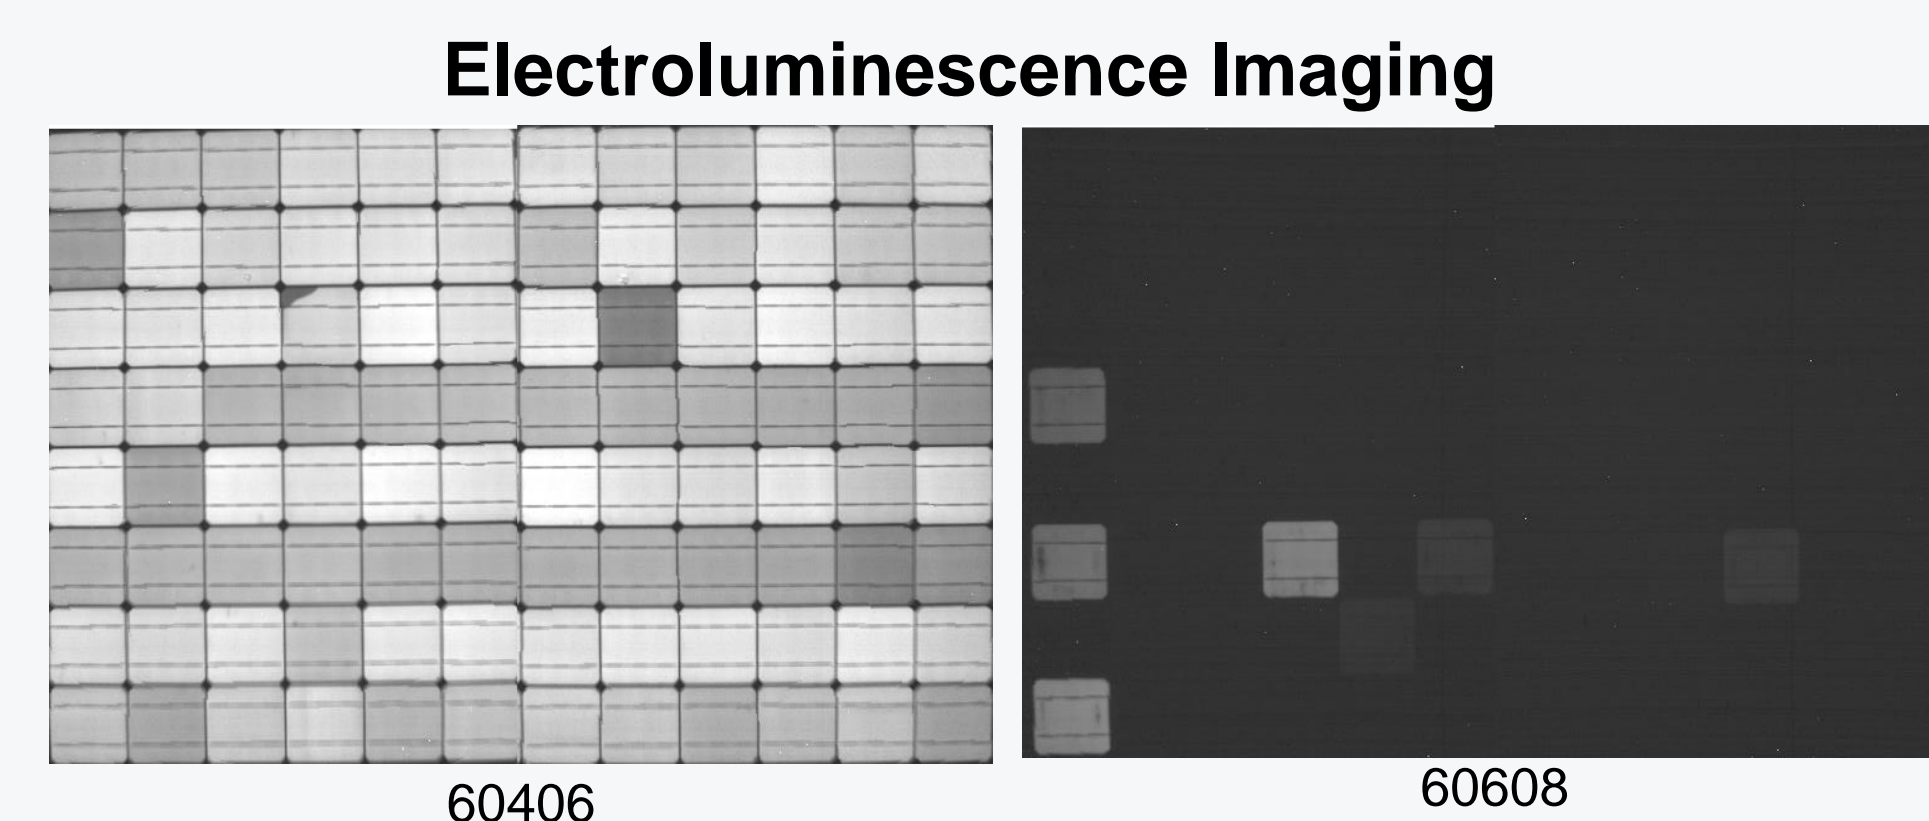
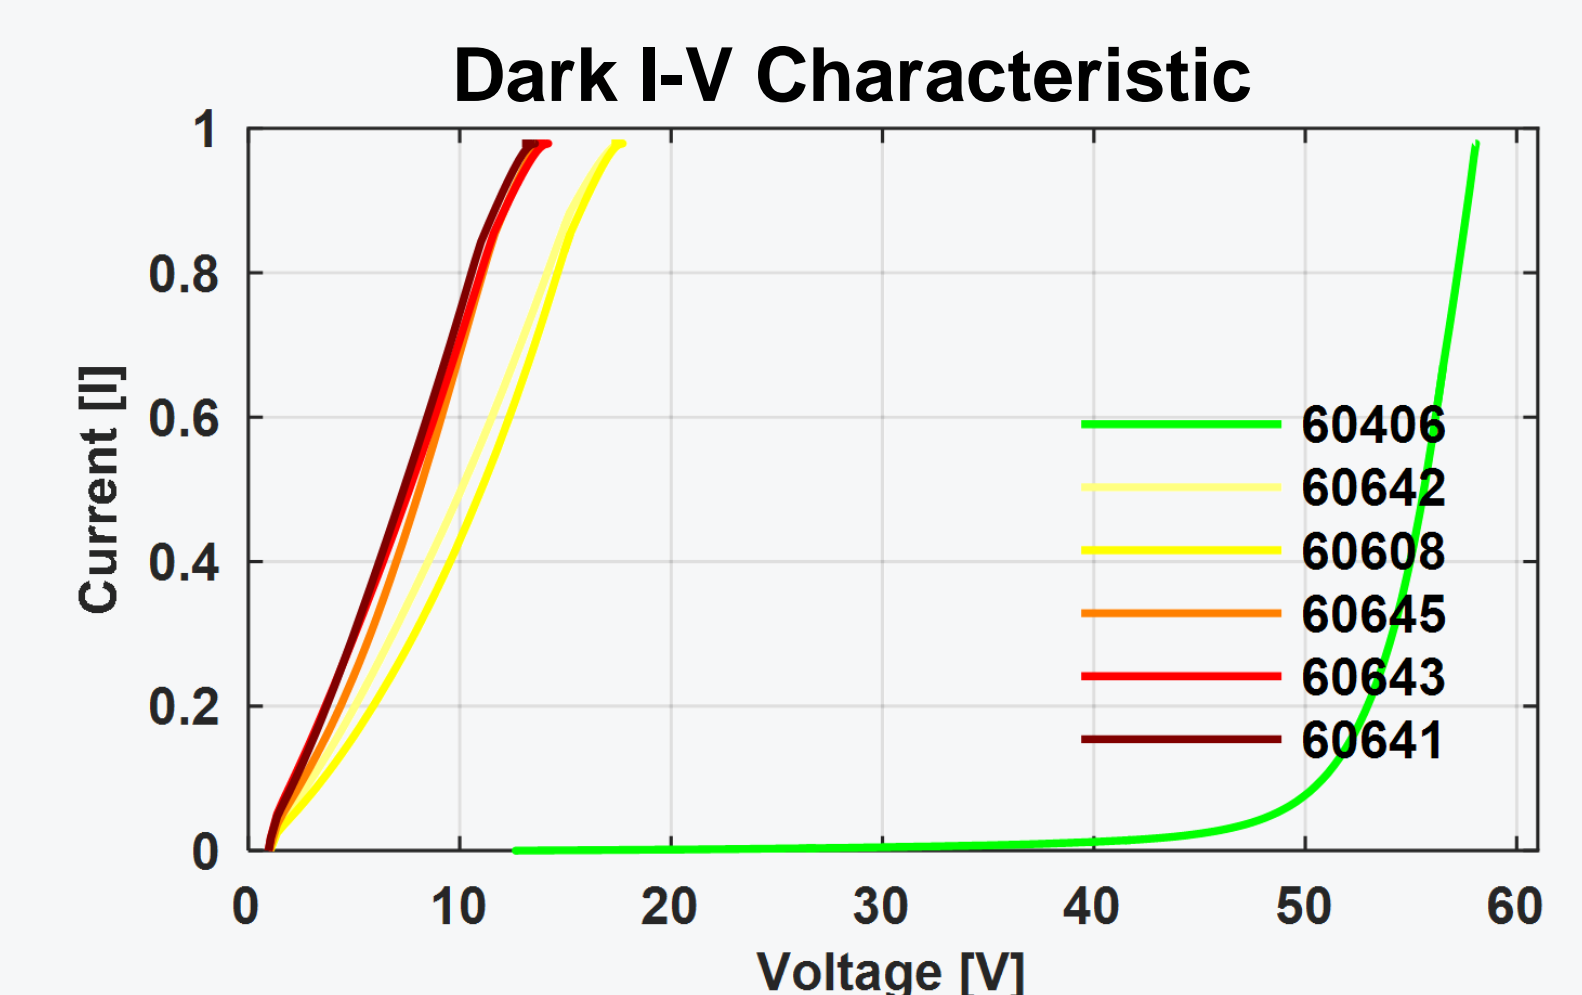
- Light and dark I-V characteristics of the PV modules correlated with the EL images point out the degradation to be PID. The shunt resistance had dropped considerably.

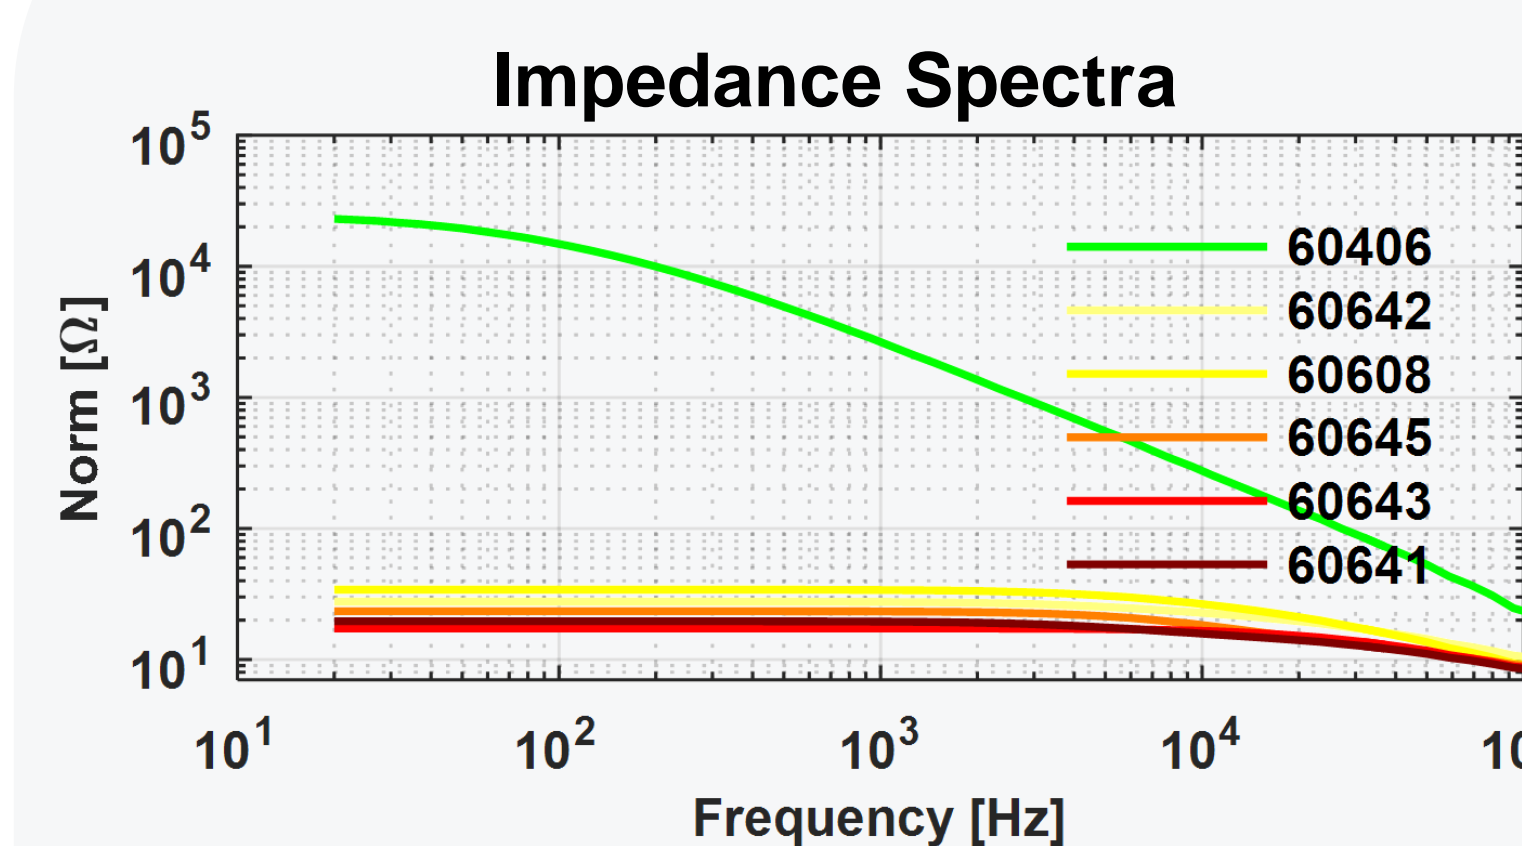
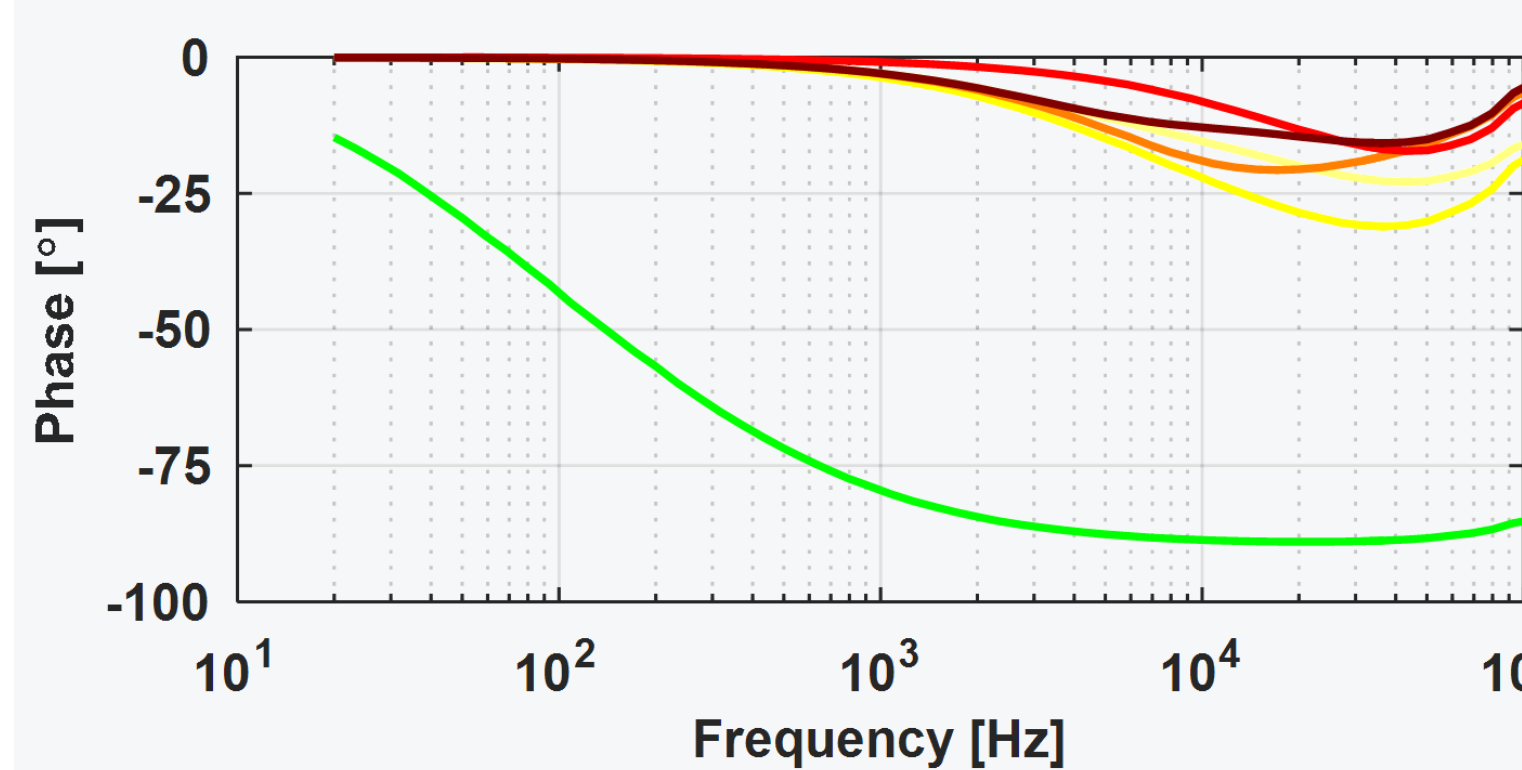
- Impedance spectra of the six PV modules, measured in dark condition in a frequency range from 20Hz to 100 kHz. The difference is evident between the best performing module (60406) and the others.

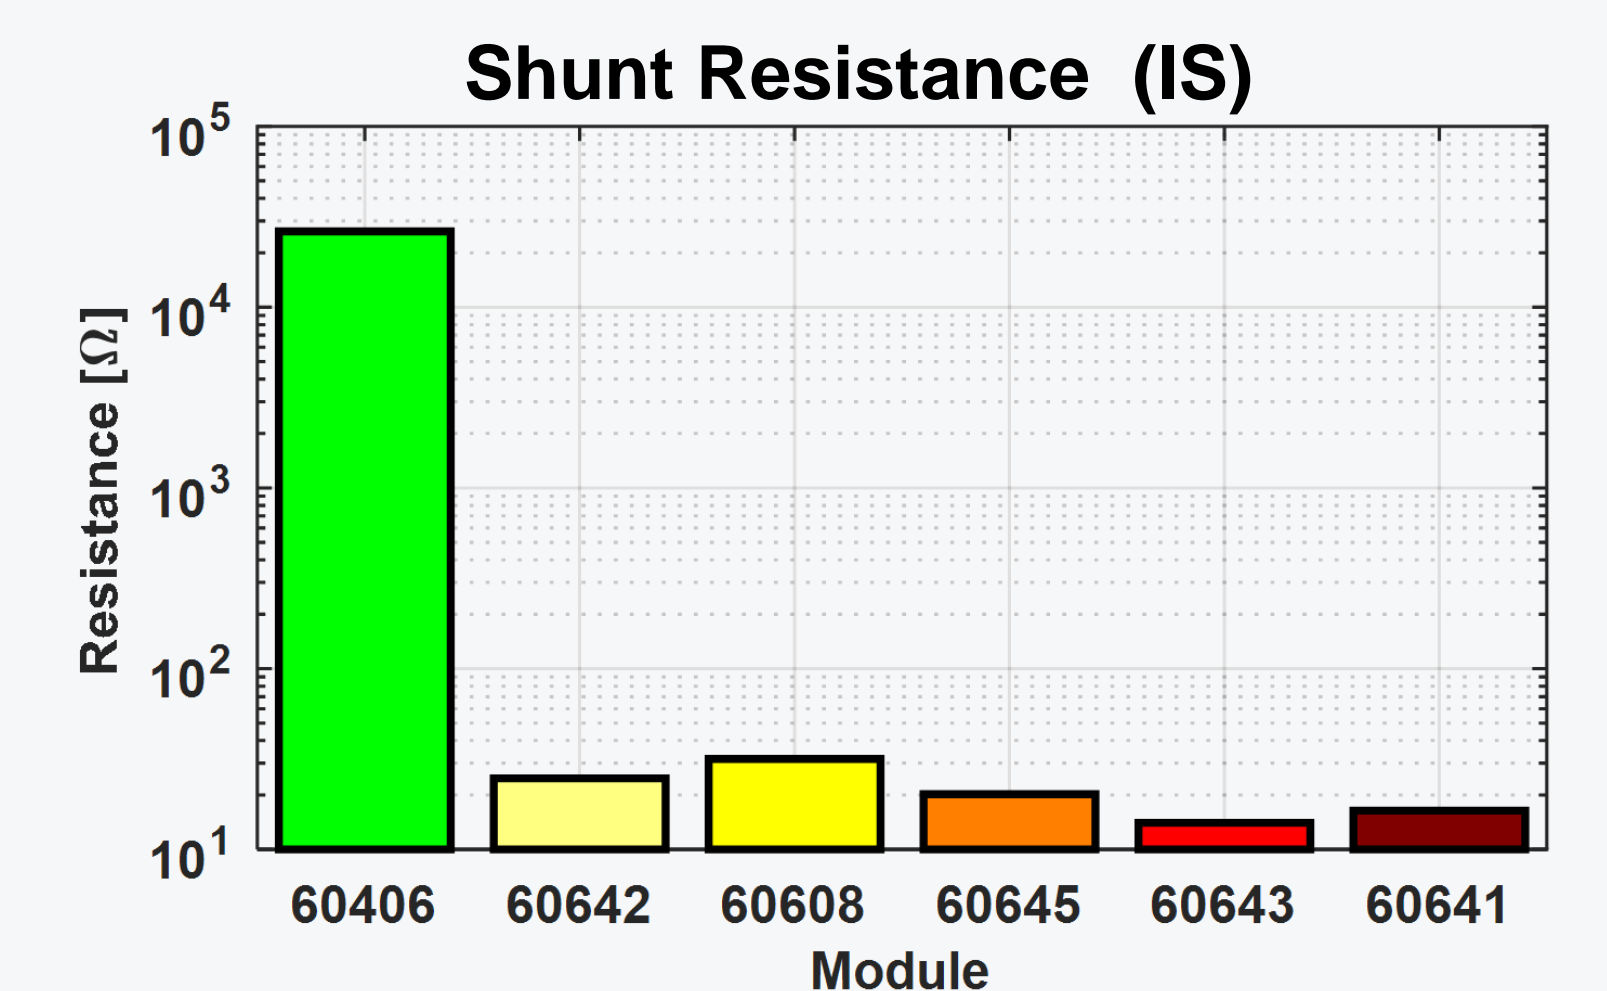
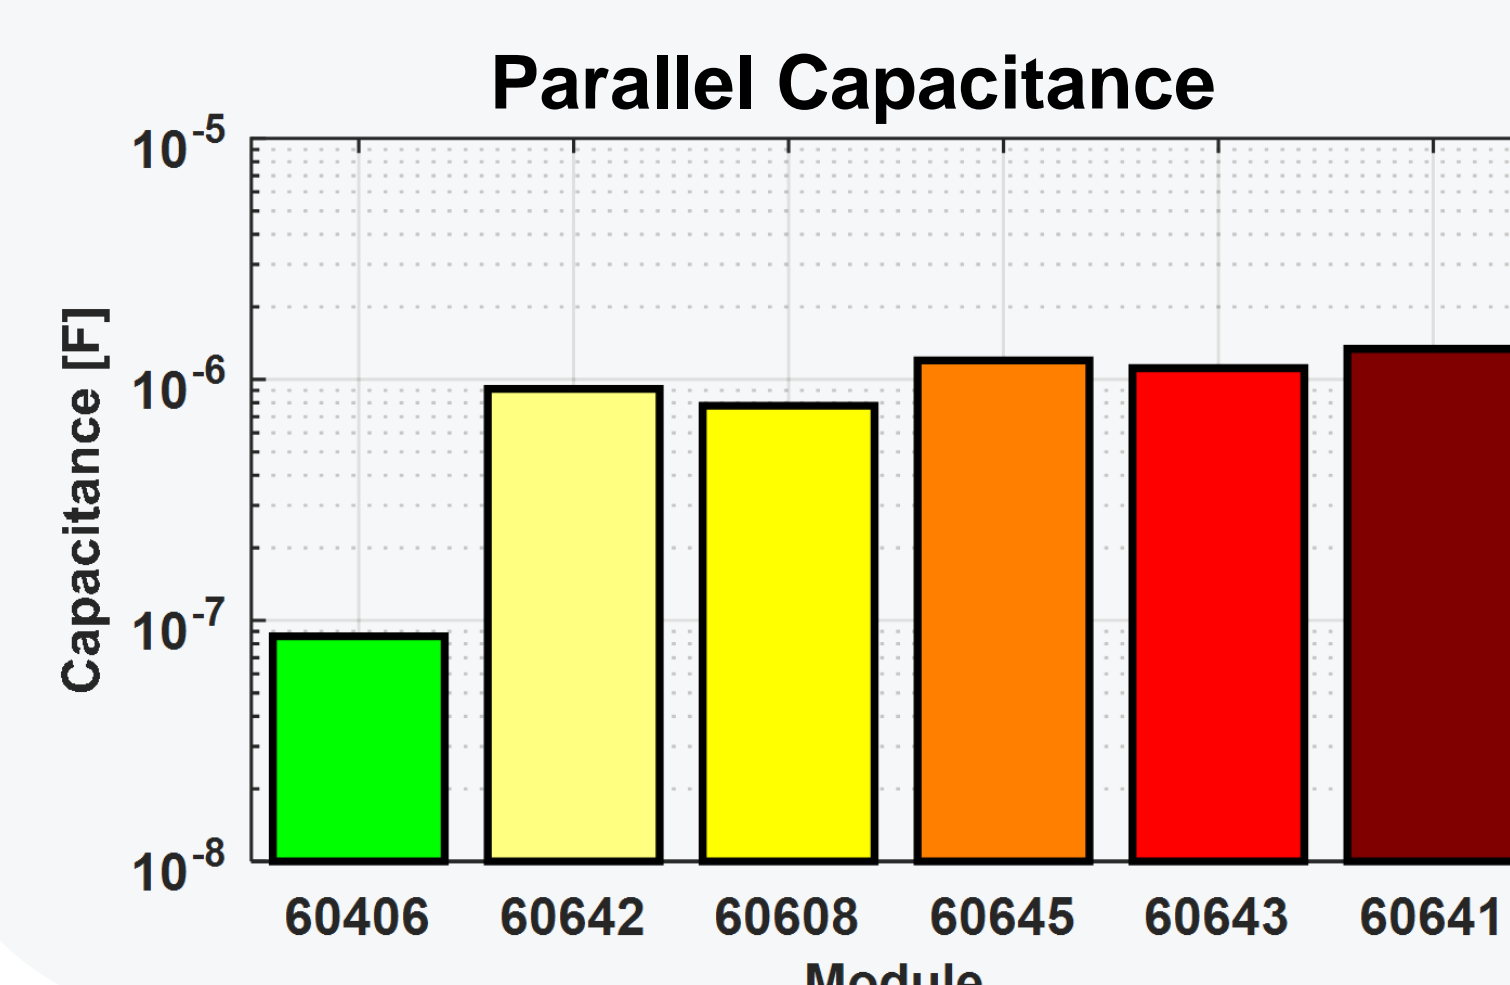
- Shunt resistance values determined from the IS measurements illustrate the same picture as the other characterizations. The PID modules have an  $R_p$  much lower than the typical value for c-Si PV panels, which is around few kΩ.

- The parallel capacitance shows one order of magnitude increase in value for the degraded modules in comparison to the well performing module. The change is significant and supports the hypothesis that the AC parameters can be used to observe changes in the PV panel state.

**Conclusion** — In this work a case study of c-Si PV panels that experienced PID in the field has been investigated. It has been shown that PID can affect the capacitance of PV panels, and simple IS methods can be used to detect the change in their parallel capacitance. In the study case a significant increase in capacitance has been detected in the presence of extensive PID. The results confirm the potential of IS as a diagnostic method for PV modules also in the field, however further controlled degradation tests are needed to better assess the dependency of the parallel capacitance on PID in the early stages of degradation. It should be noted that other types of faults may have a similar effect on the parallel capacitance, therefore further research is needed for assessing the value of this parameter in presence of various faults.
